ROYAL COMMISSION

QUEBEC BRIDGE INQUIRY

1907

MINUTES OF PROCEEDINGS

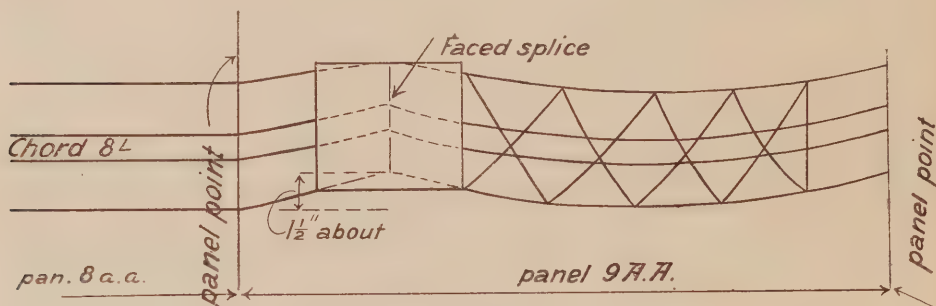
The bend in the chord starts at the faced splice at the shore end and not at the edge of the splice batten. It appears from this that at least a large portion of the

bend was in the chord when the top and bottom splice battens were riveted early in June. This and the fact that the lacing angles are not distorted, leads me to believe that the ribs were bent before erection, in spite of the fact that Mr. Clark and Kinloch think all the ribs were straight when the chord was repaired.

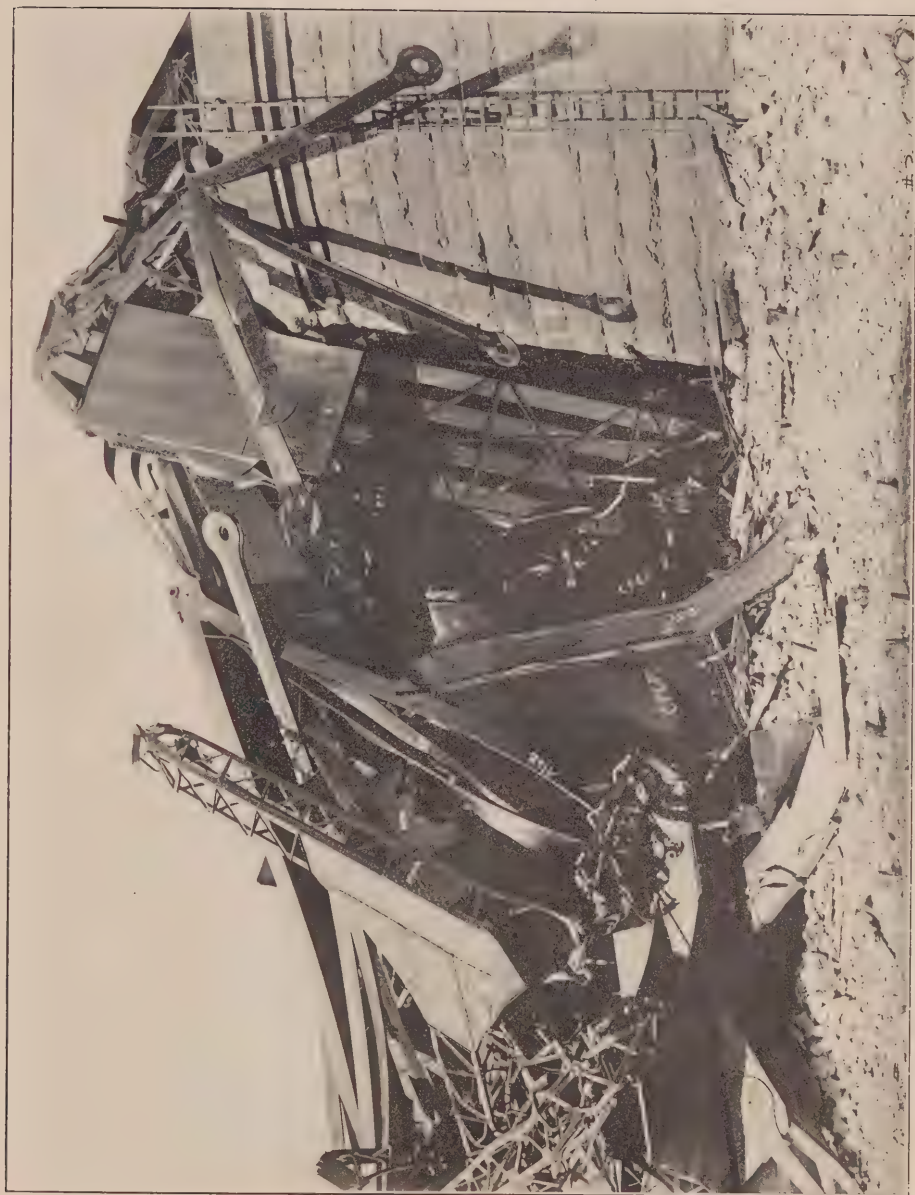
1. View showing the centre post cap, finials, diagonal T5 and the upper chords in panels 9 and 10 Anchor Arm. The centre post has been practically bent double over the main pier by the drag of the cantilever arm. Note that the end of the pier is clear of wreckage.

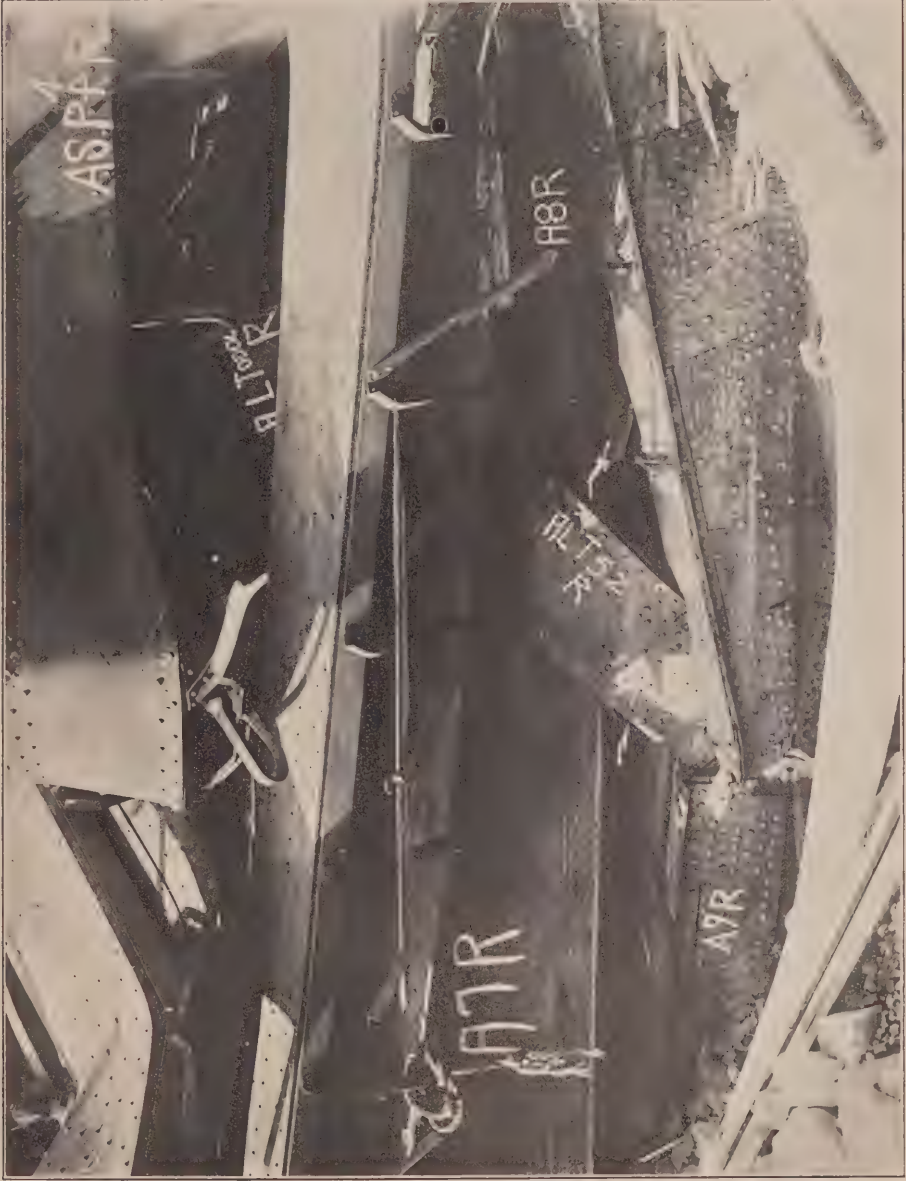
3. View from the east at the 9-10 R joint in the lower chord. Note how 7R and 8R have been thrust over 9R and 10R. This view is almost identical with one taken by Mr. Kinloch.

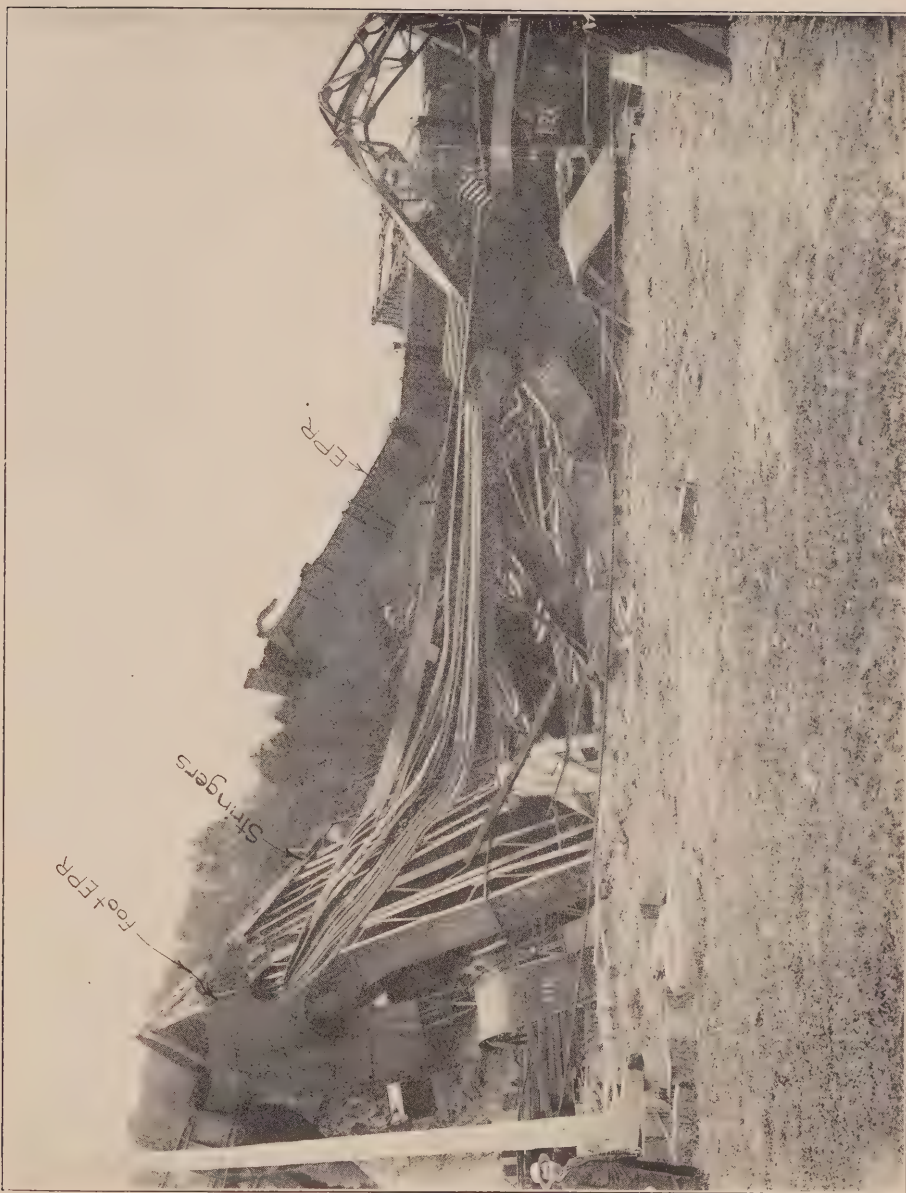
7. View near the top of post P1R. Note the line of the diagonal eyebars ATI, and the top chord eyebars AA.

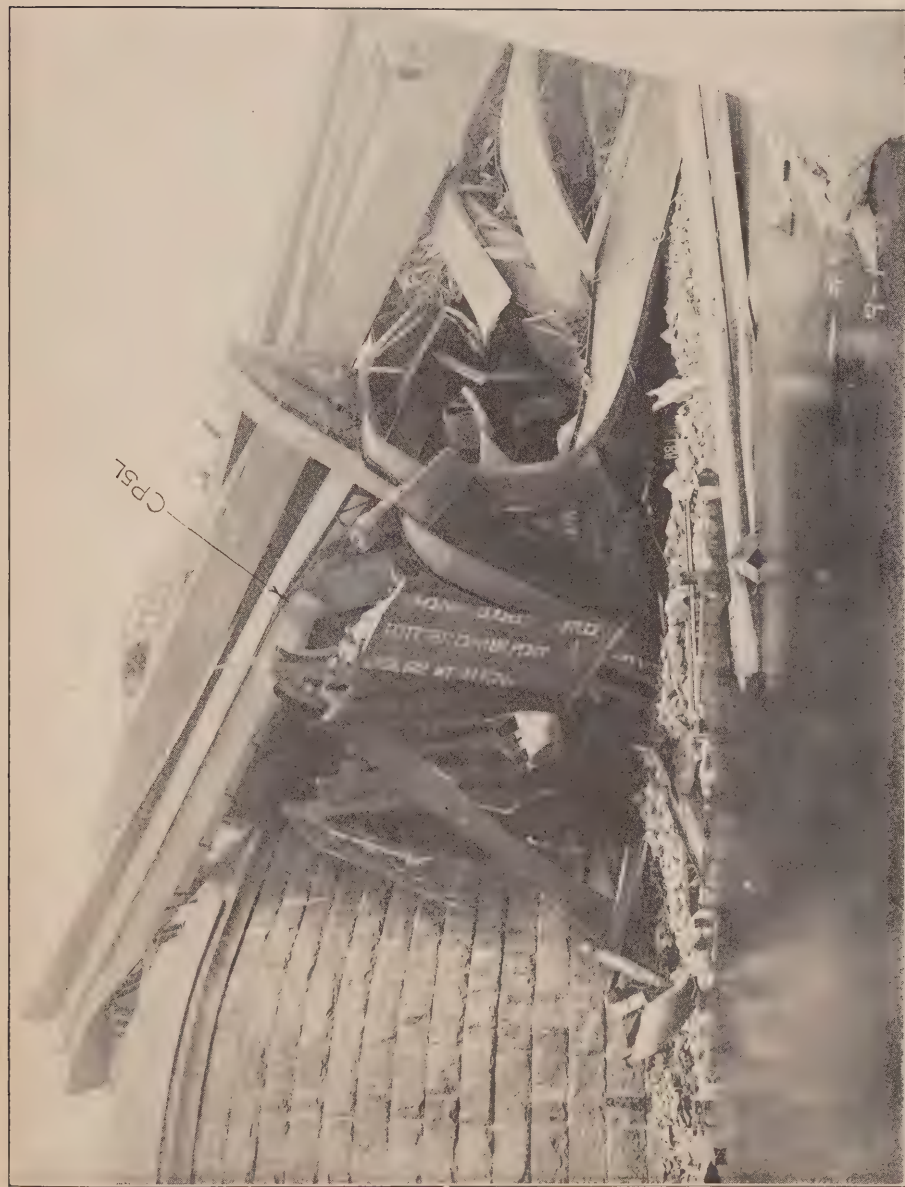
8. View with the foot of EPR on the left. Note the buckling of chord AIR. Other views of this member are to be found in Exhibit 35 and Appendix No. 12. Note the stringer system. ASPIR in the foreground has been twisted and has got in between the webs of A2R which is lying nearly at right angles to its original position.

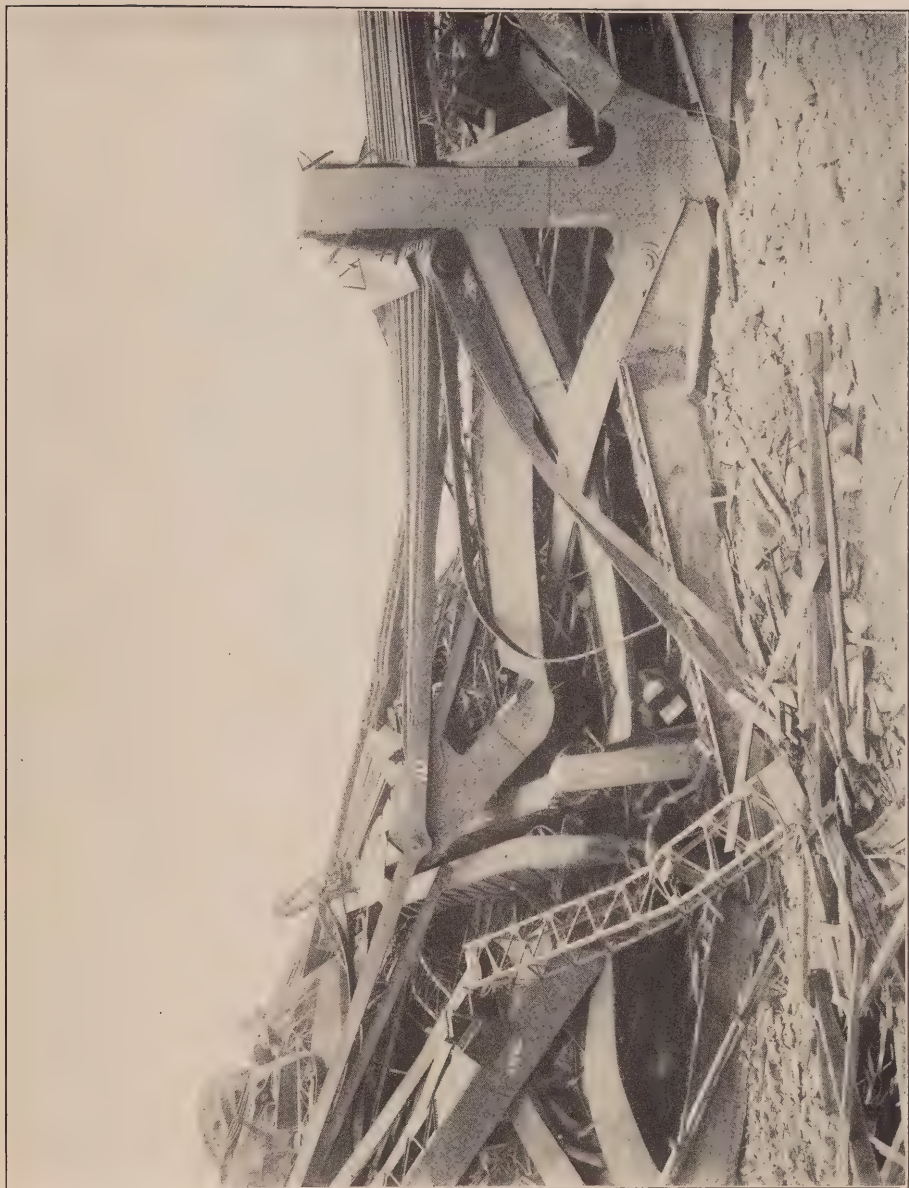
12. View from the west showing the beginning of the first 180° bend in chord A9L.

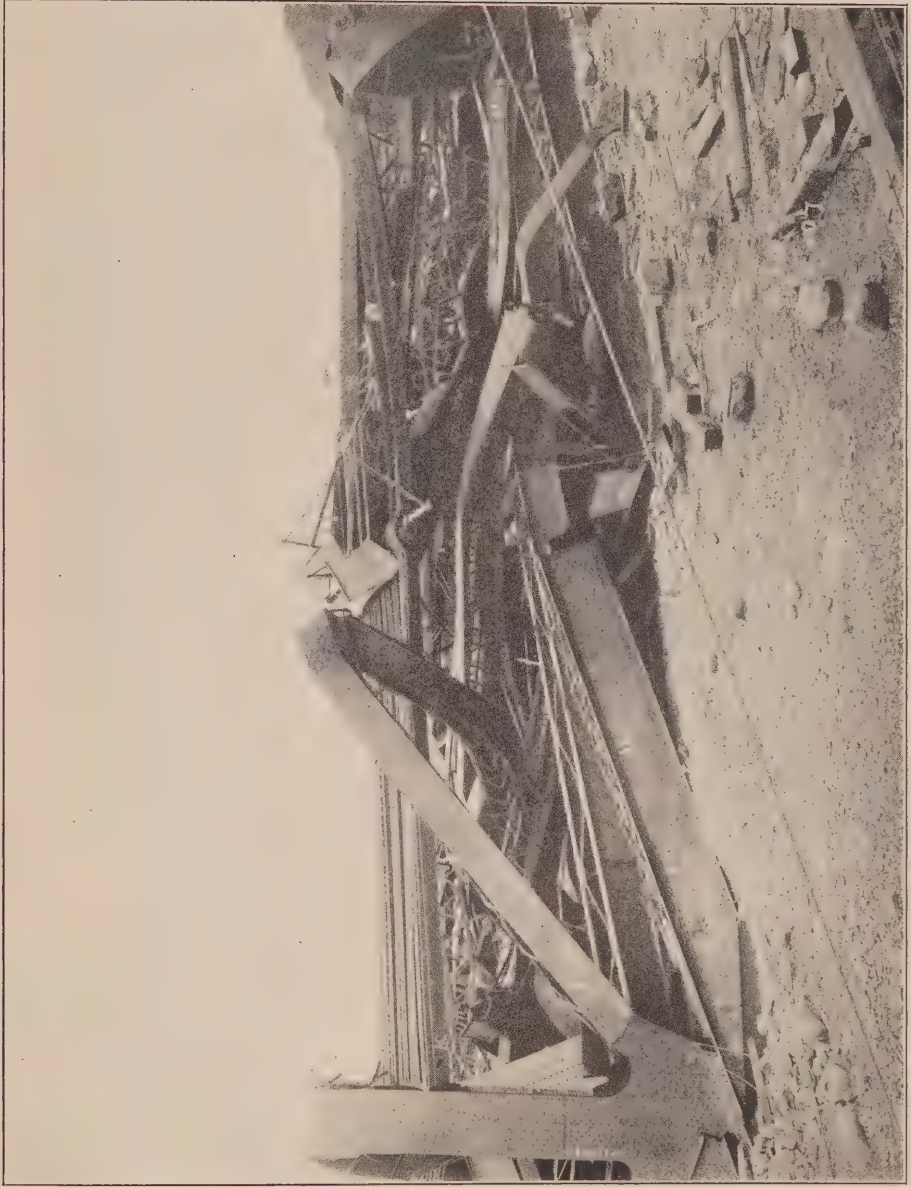
13. View showing the foot of post P3L. Note the distortion of this post and the effect of the foundation holes on the lower chords.

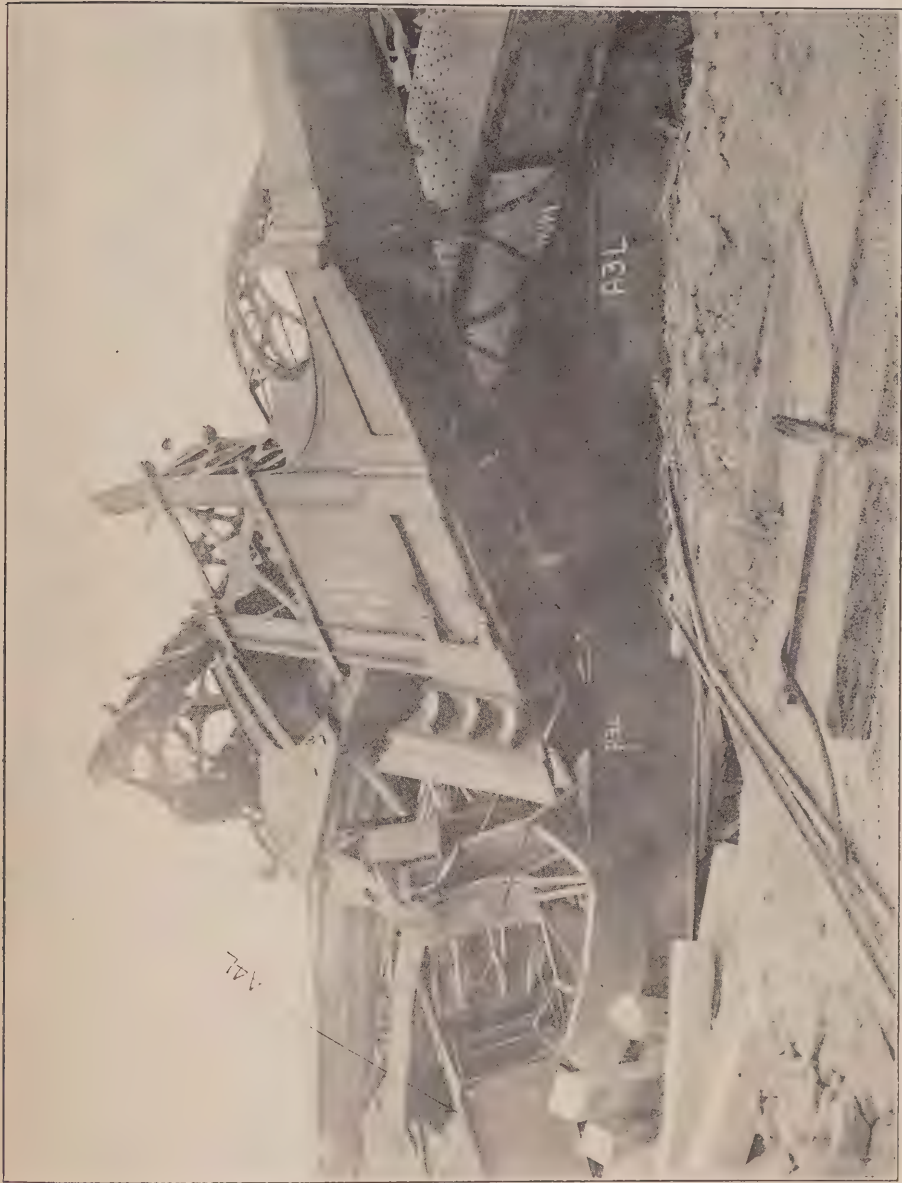
15. View showing the foot of post P2L. Note how the ribs of ASP2 cut the cover plate of A4L at some stage of the fall ; the camber block in the foreground ; and the condition of the link connecting AT2 and AT20.

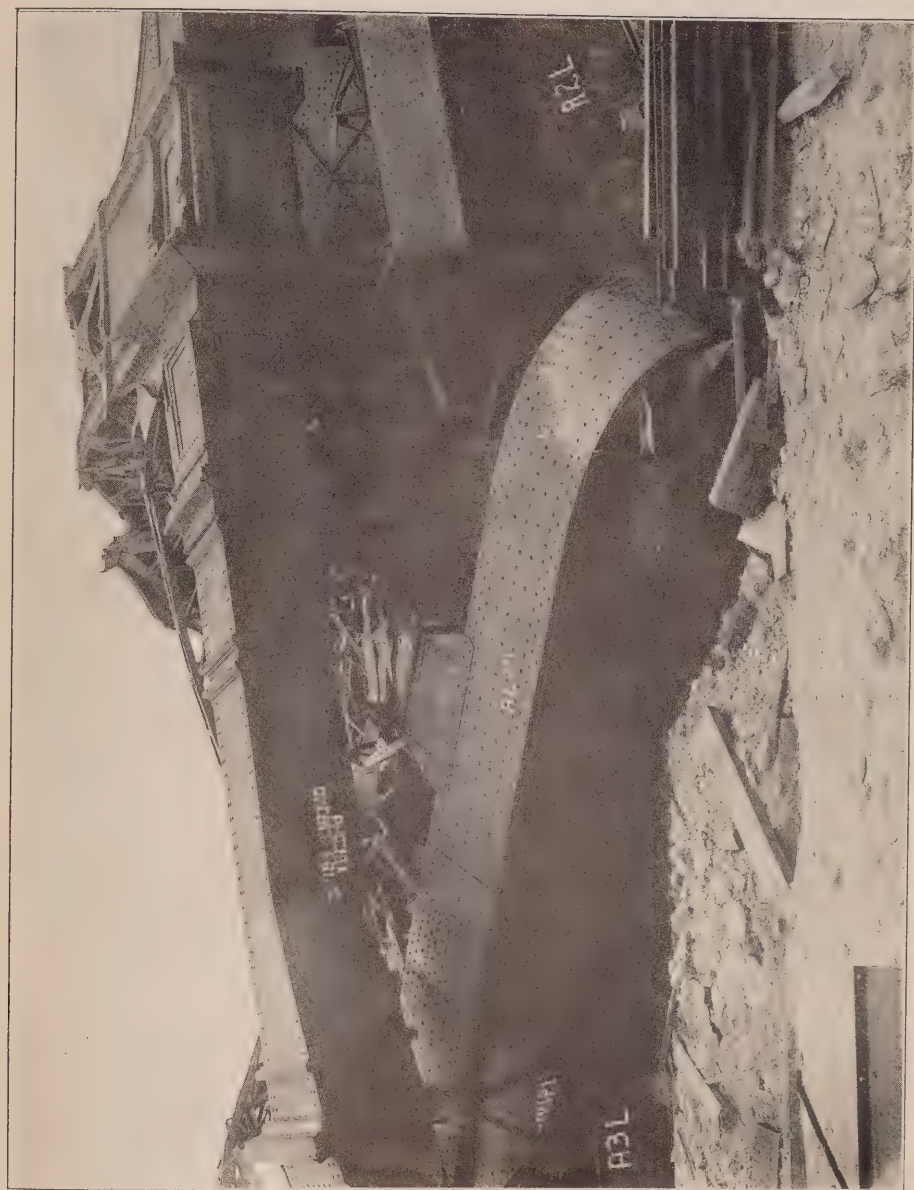
16. View showing the wreck of the portal. Note the fracture of the splice plates between A3L and A4L.

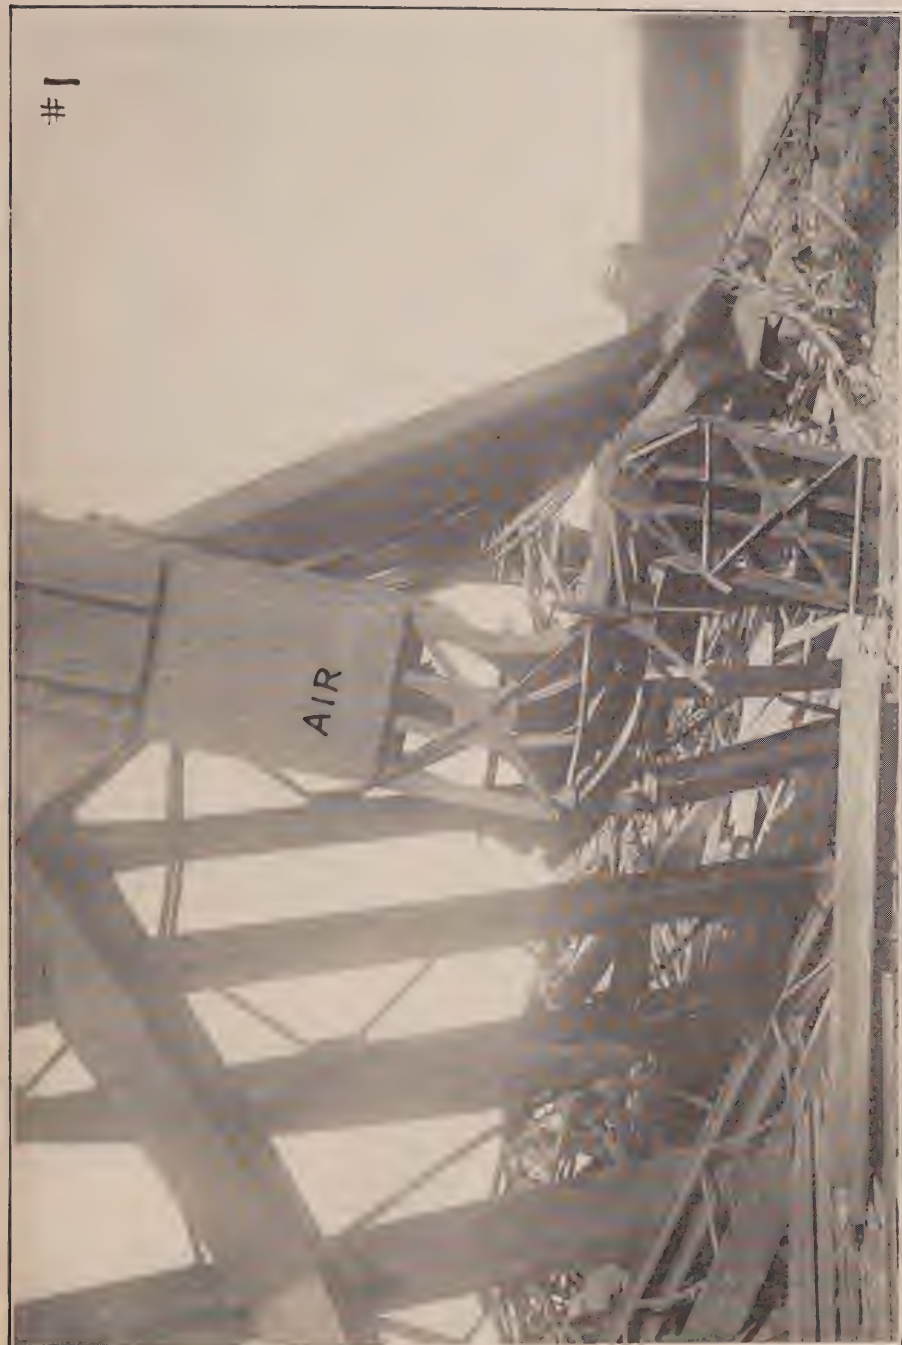
#1

1. Shows buckling on chord AIR between cover plates; also efficiency of covers and diaphragms in keeping members straight. The offset from the edge of the upper cover plate in the photograph to the corresponding edge of the lower cover plate is 7.11", and the offset between the two plates at right angles to the plane of the picture is 9" 0. The crowd apparently struck the ground end on and the buckling shown resulted.

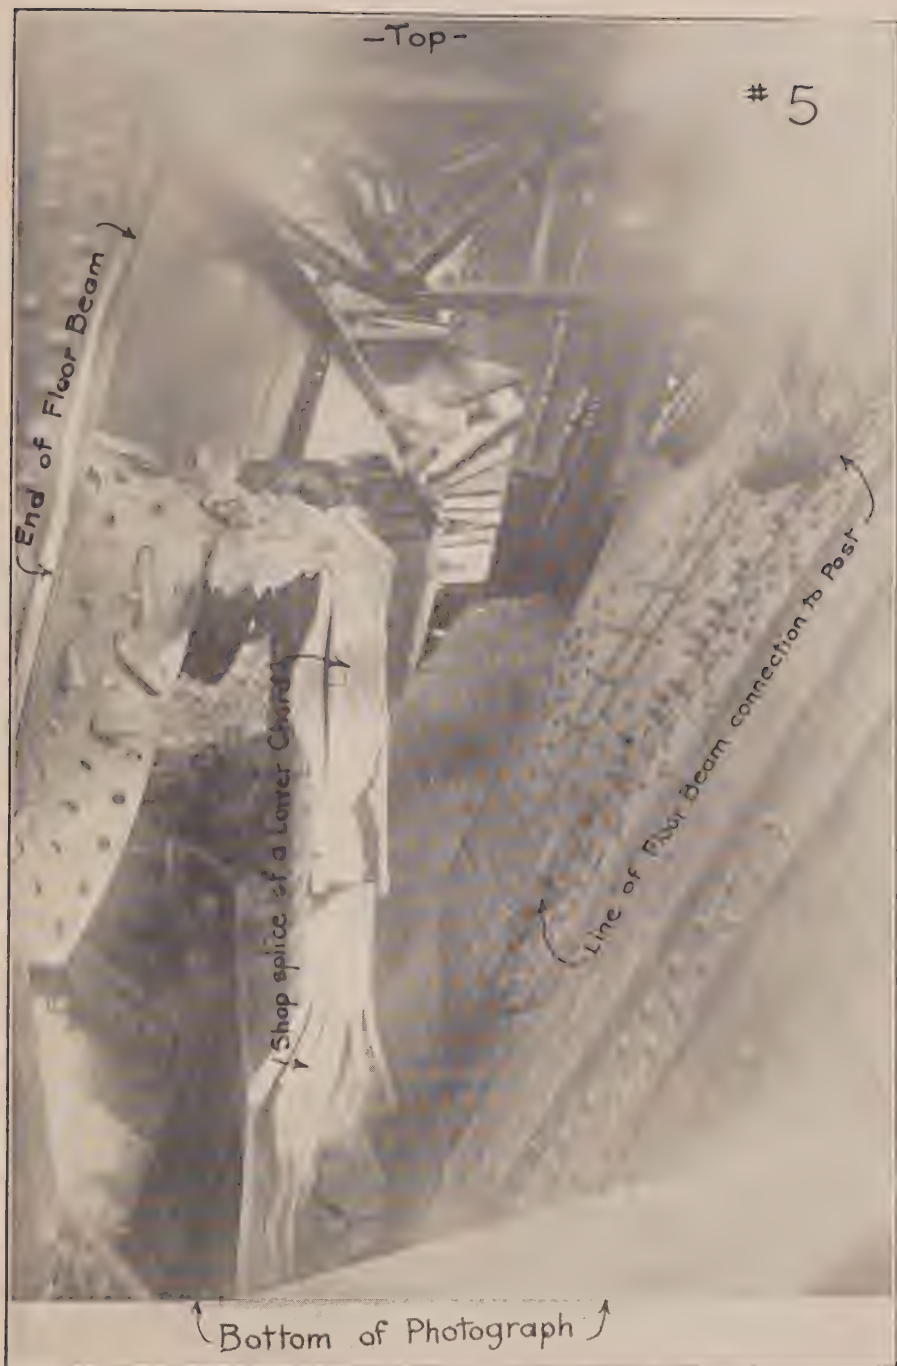
5

5. Shows typical rupture of connection of floor beam to post. This action is undoubtedly the result of the fall. Note the general uniform strength of the joint as indicated by the failure in various ways of the floor beam connection angles, and also of the rivets. In this instance, where the rivets failed they yielded by direct tension, and almost without exception necked down in the same manner as a perfect tension specimen pulled in the laboratory.

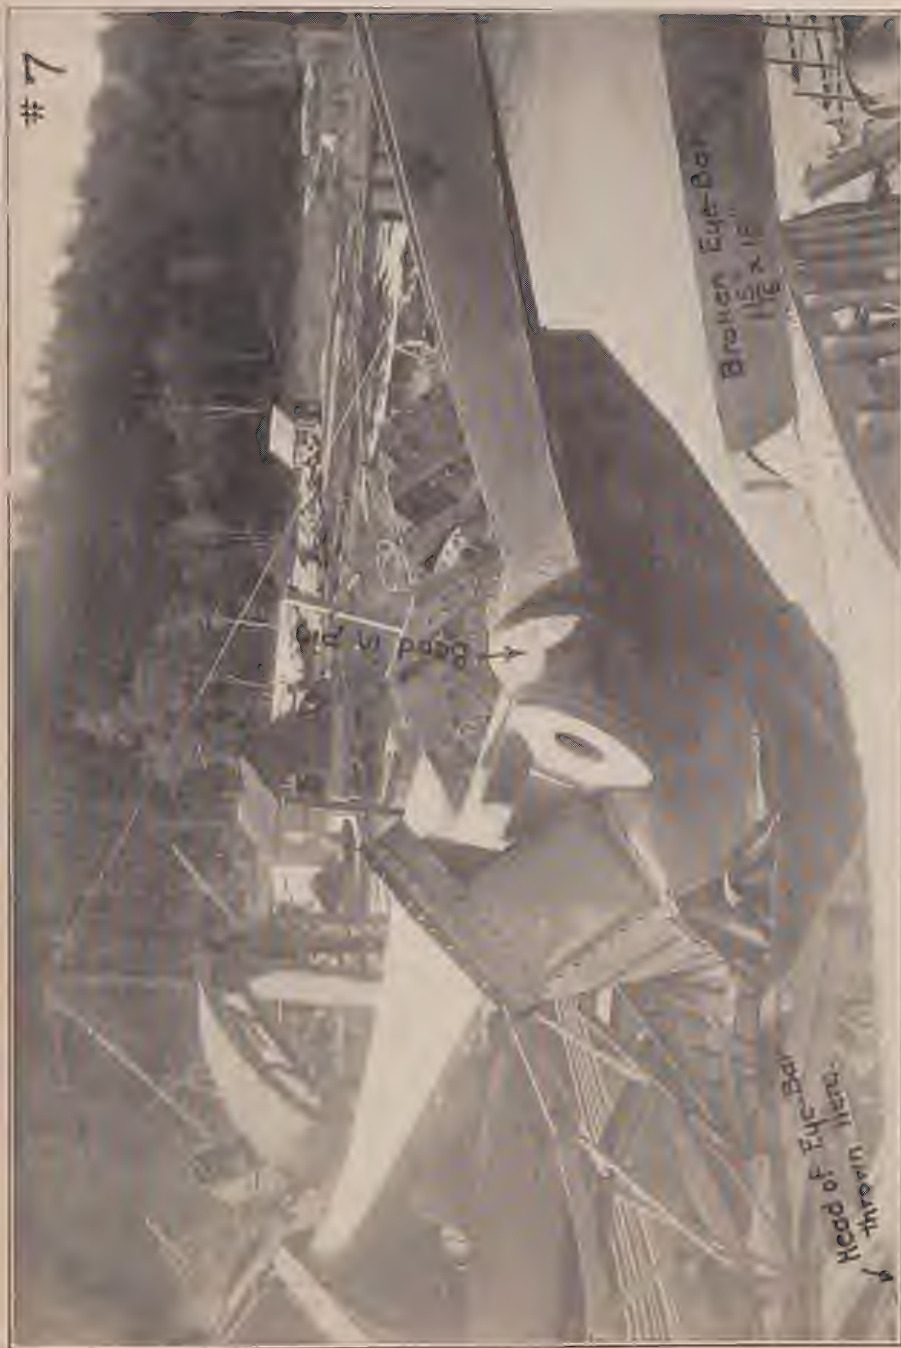
#7

7. Shows the one bent jaw on the left. Near the pit is twenty tons of metal, including the only broken eye bar, which will be observed resting on a building corner at the lower right hand side of the picture. The head of this bar was thrown about 15 feet to the left. There is every evidence that the blow which caused the damage to the work of this post also bent the eye bar.

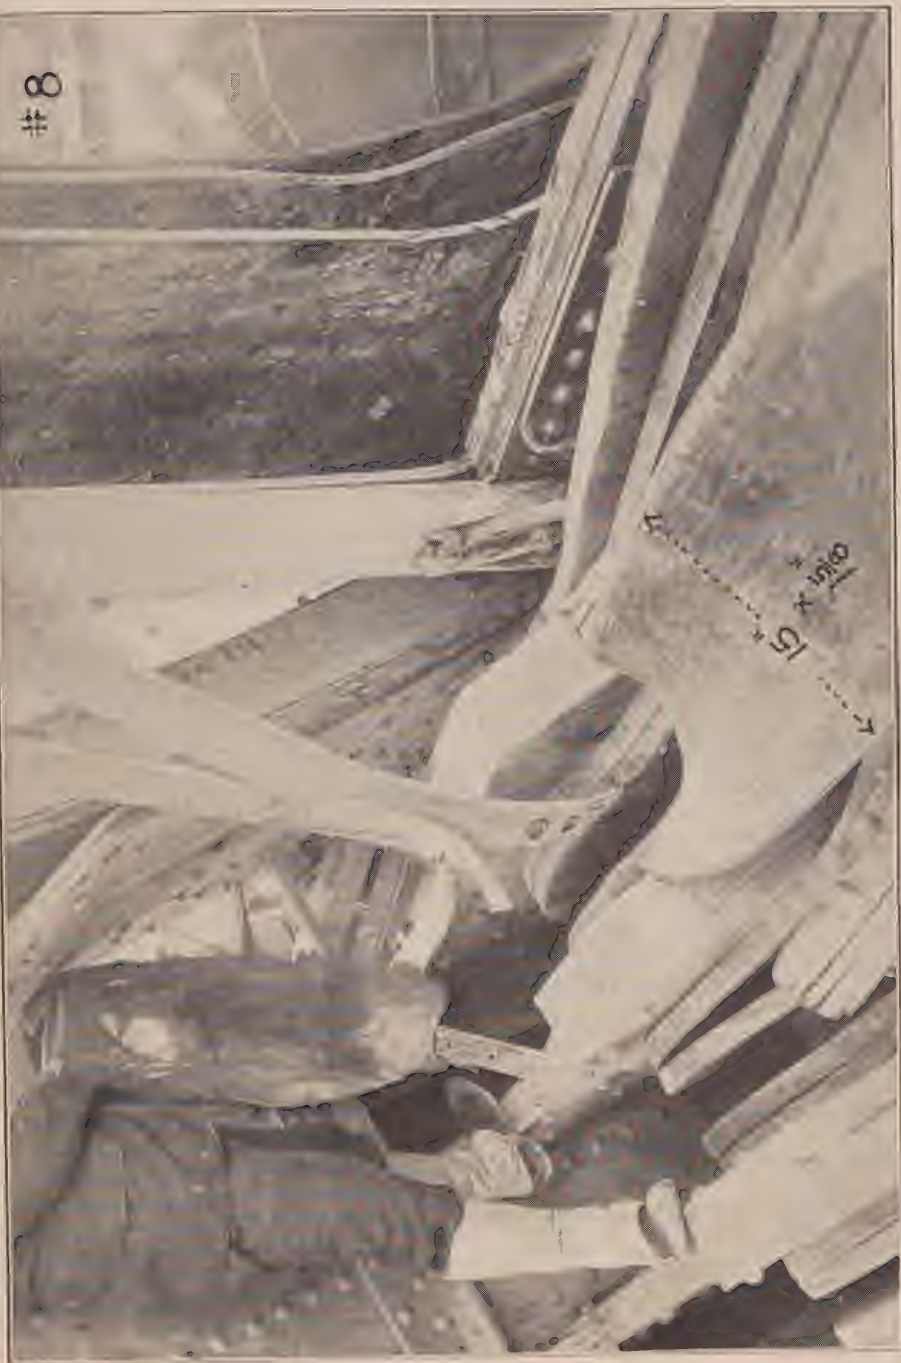
8. Shows a remarkable test of the quality of steel in the wire rope. This bar was one of a set of trials designed, and its length was 14' x 13'. The forces set up by the fall twisted the body of the bar through an angle of 90 degrees in a distance of about 2½ feet while the head of the bar still remains in its original position on the pin. There is no evidence of any failure of the bar on the accessible surfaces.

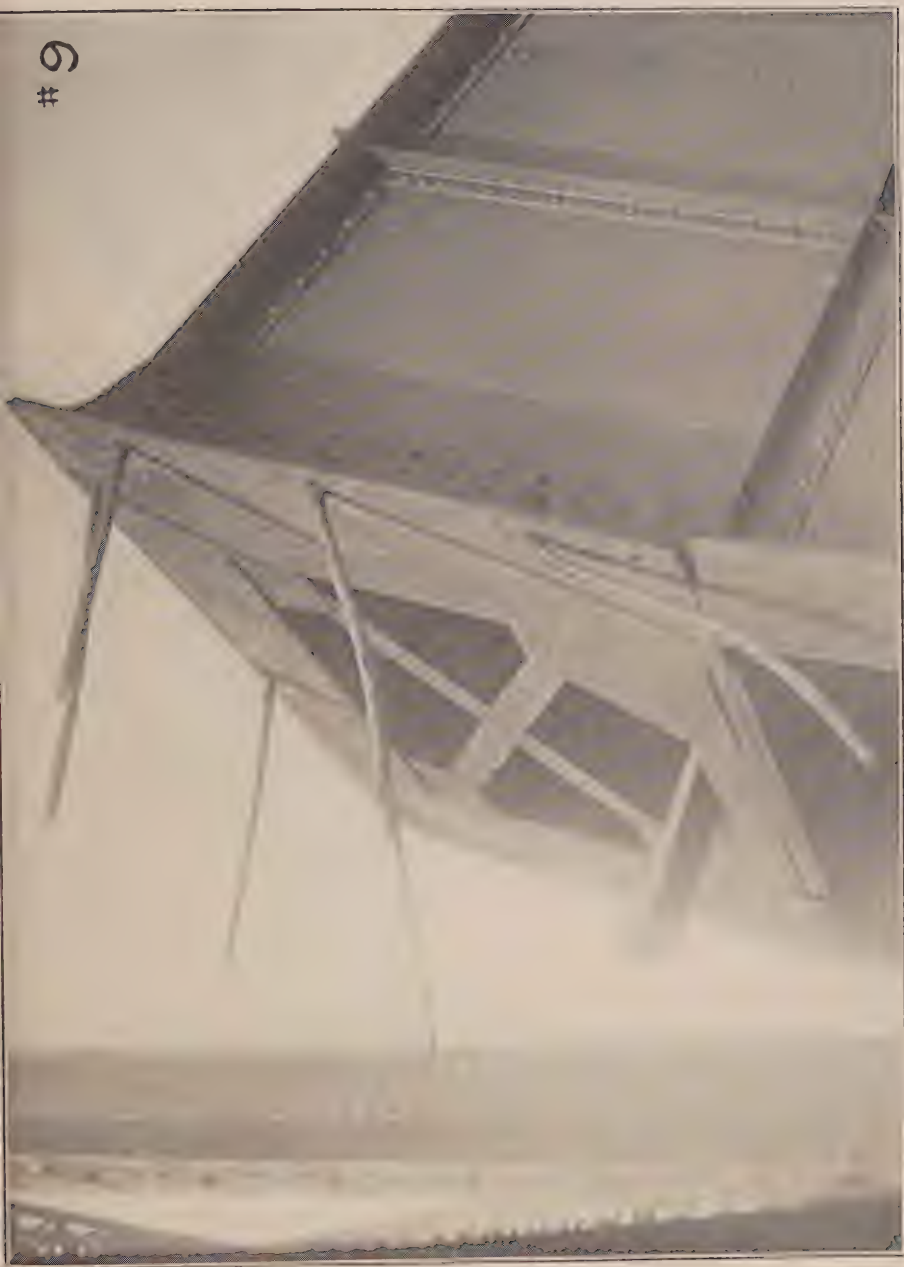
9 Shows 12 inch and 16 inch wheels hold the base of each shaft surrounding the eye bar hanger made at the top of the anchor pier. These hails were necessary steel rods, 4 feet 9 inches long, and weighed over three tons each on completion. The hails in which they were set were drilled in the granite. The hails were supposed to have been grouted in with pure Portland cement. In every case where they tested direct tension they pulled bodily out of the masonry.

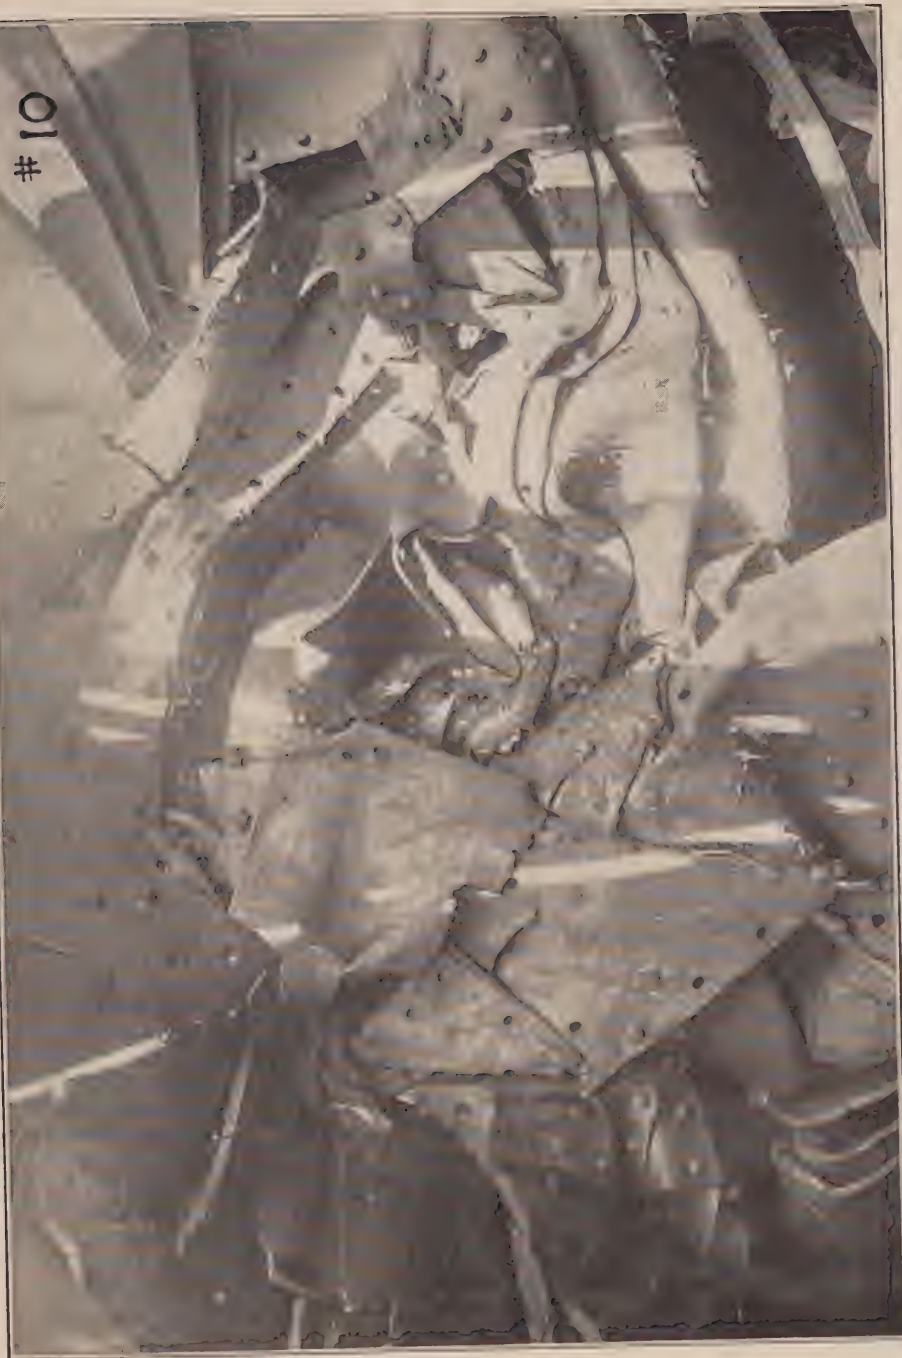
10

10. Shows the complete chaos to be seen at some points of the wreckage. This view is interesting only as an indication of the magnitude of the forces at work during the catastrophe. Even in this distorted mass there is no evidence of poor material.

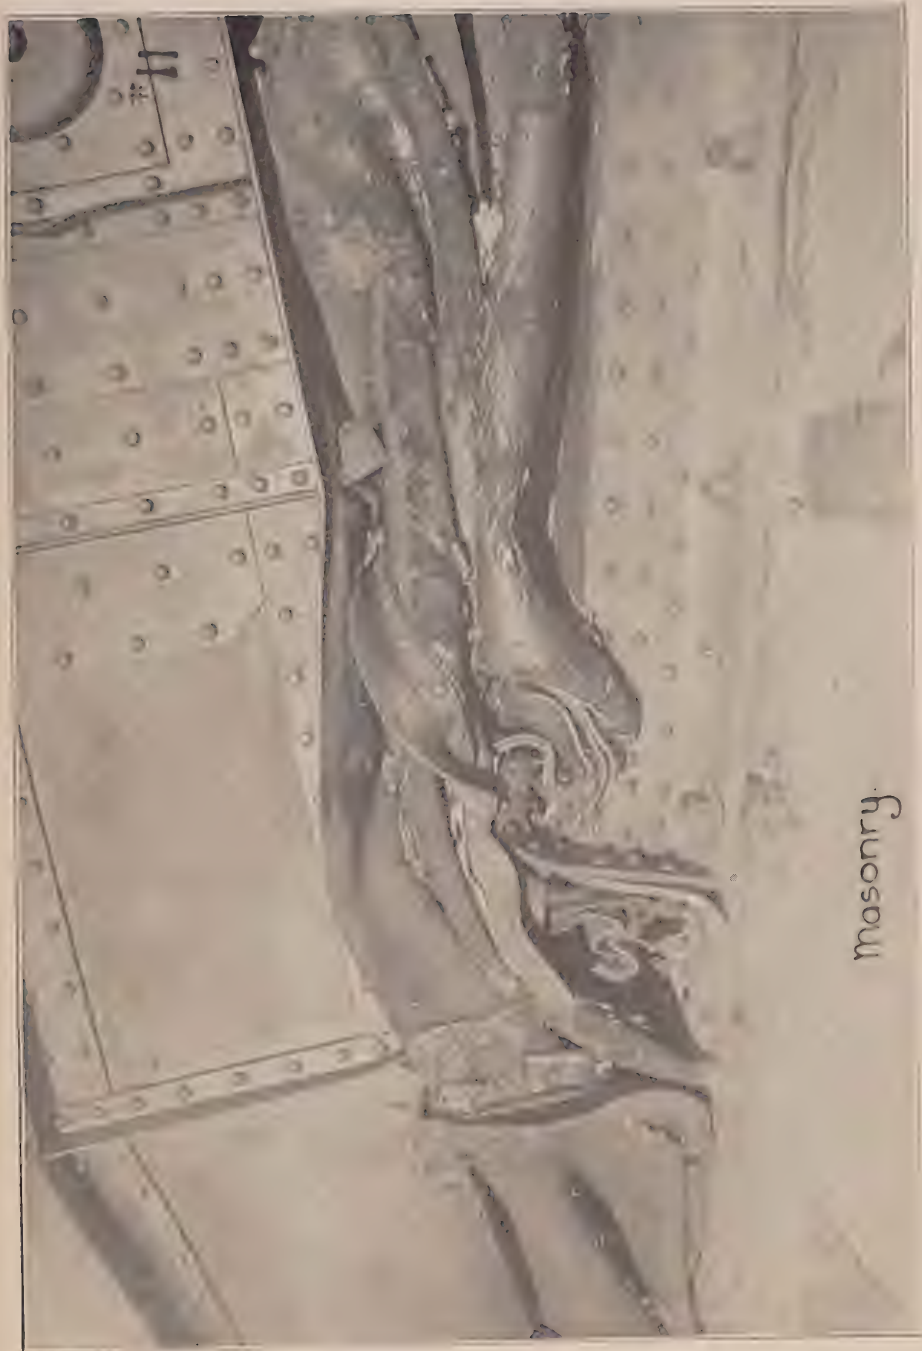
11 Shows the falling of the plates of the shell containing the armor-plates on the armor-plate. The folds in this instance resemble in every way the action of heavy felt under similar treatment.

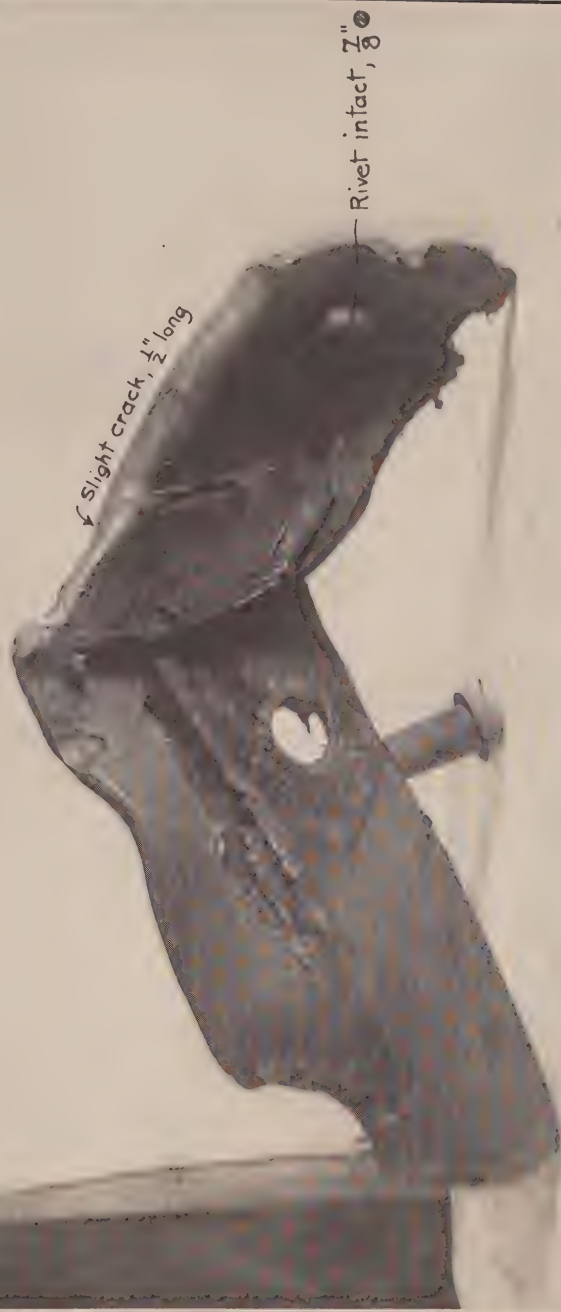
12

12. Shows a fragment of an angle $4 \times 3 \times \frac{1}{2}$. During the progress of the fall this angle was opened flat and bent backwards nearly at right angles to the axis, and hammered down to close contact. There is in this case only a slight crack about half inch long on the exterior of the sharpest bend. Note the enlarged rivet hole. This specimen contains a rivet intact, the connecting pieces having parted from it by tearing of rivet holes.

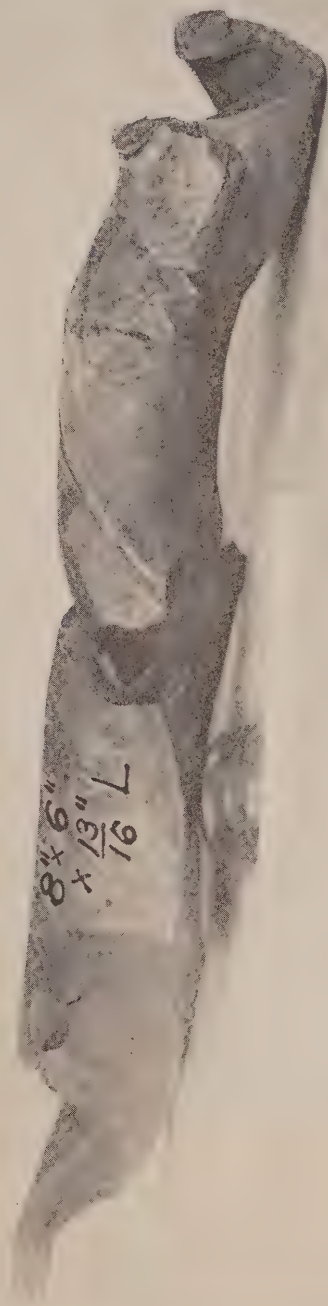
13

13. Shows a fragment of an 8" x 6" x $\frac{13}{16}$ " angle torn to pieces and closed together to nearly close contact.

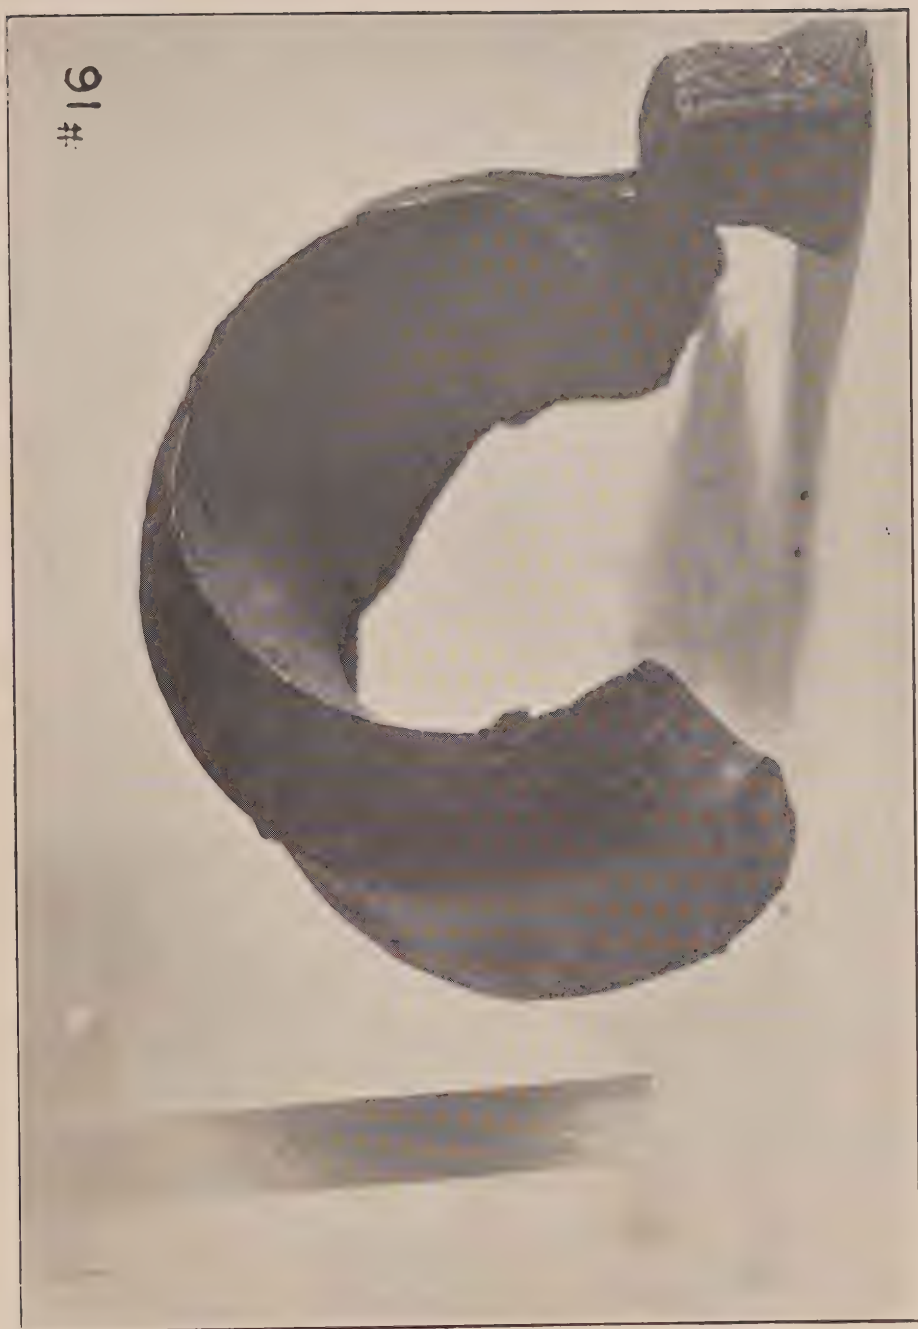
16. Shows a fragment of $\frac{3}{4}$ " plate turn, sheared and bent.

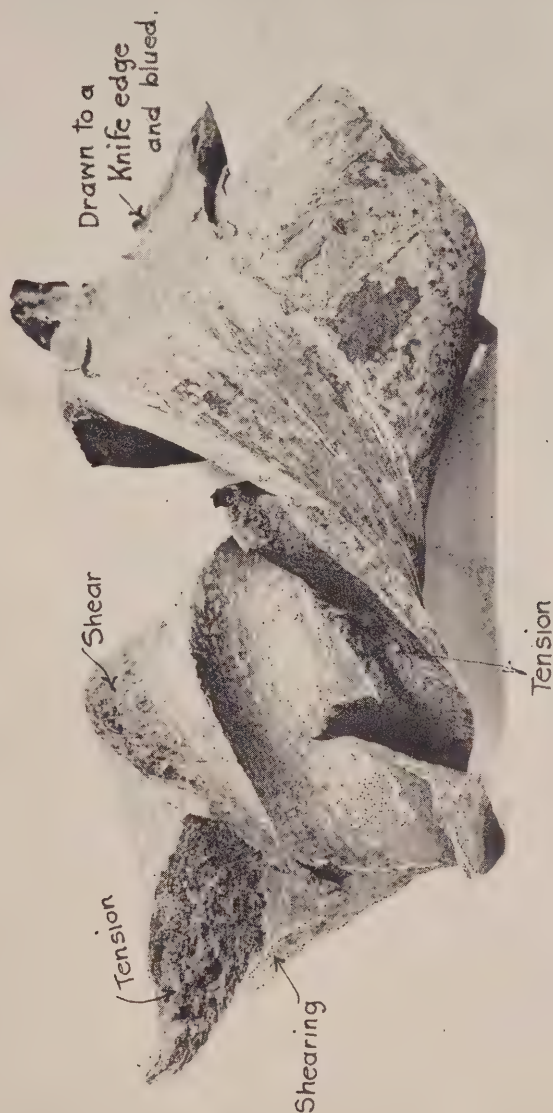
17. Shows a fragment of $\frac{1}{2}$ " plate originally about 2" x 6". This specimen is unique, showing clearly its quality by having been bent spirally as if a three-eighths rod had been used for a core about which to bend it. It also exhibits a beautiful fracture from shearing. It has a perfectly fibrous fracture from failure in tension. Its ductility is proven by a terrific sliding force which indented and scored it throughout its whole length and finally drew it to a knife edge. This action set up so much heat that the specimen is perfectly blued at this last named point. This specimen is photographed to exact size.

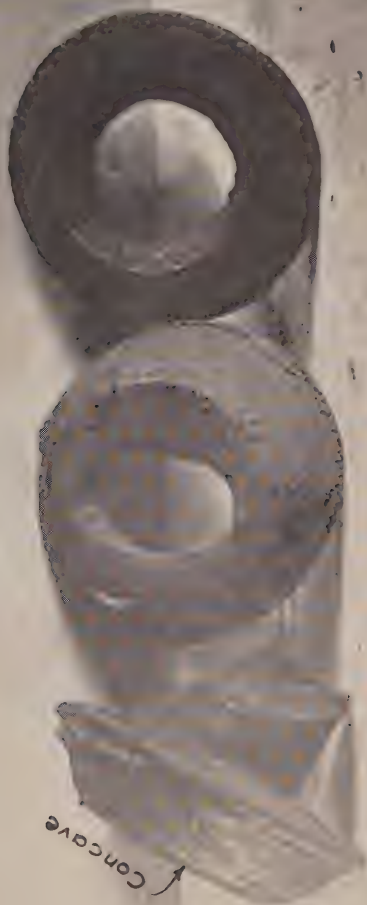
- 18 Shows three typical rivet failures. One where the shank pulled out of the head leaving a perfect ring (analyzer where the shank did not pull evenly out of the head, but left a flat portion on one side of the circle, (note the concave surface of the segment due to the flow of metal in the pulling) and, in third, a rivet head in which failure started by the shank pulling through the head, but finally fracturing by drawing down a small area and creating a cup fracture by tension. The tensile surface in the head is the result of the flow of the metal during the pulling of the shank through the head.

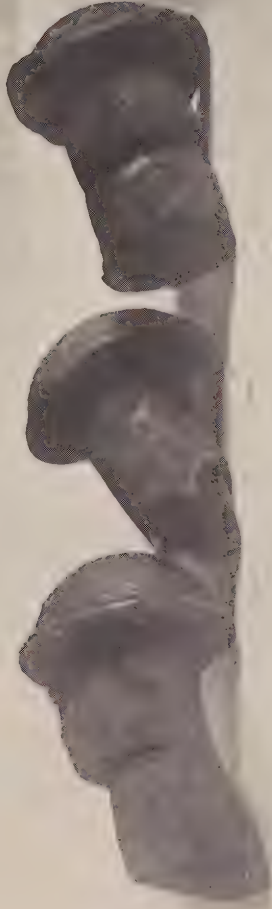
19. Shows three rivets in which the component members of the joint in which they were driven each started to shear the shanks. The outer one finally completing the shear. The middle rivet of this group shows a failure by direct tension. (Note the reduction in area of the shank).
